CASE STUDY

FEBRUARY, 1978

CONTROLLED CRACKING OF SOIL CEMENT BASE COURSE

ANCRAM-COPAKE COUNTY ROAD 55 FASS 74-1 COLUMBIA COUNTY PIN 8540.00

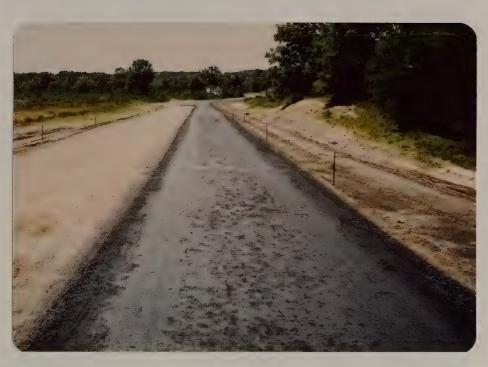
PHOTO 5
SOIL CEMENT COURSE AFTER APPLICATION
OF BITUMINOUS SEAL COAT

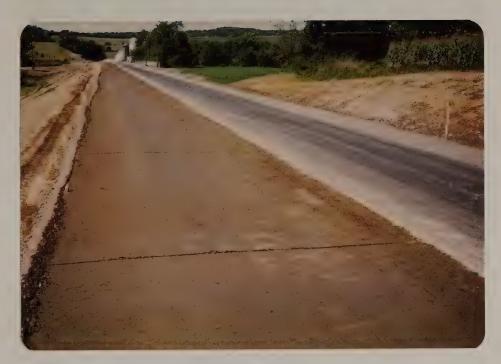
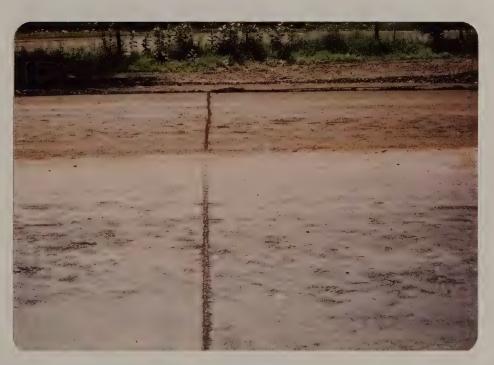
РНОТО 6

In the experimental section, the reinforcing bars were set in place just prior to final rolling by the smooth steel wheel roller. In the rolling operation, the bars were "punched" into the top of the soil cement course and then removed and moved ahead, resulting in the desired "built-in" shrinkage joint (See Photos 6 & 7). No construction problems were encountered in obtaining the groove.

PHOTO 7
"BUILT-IN" SHRINKAGE JOINTS IN TEST SECTION

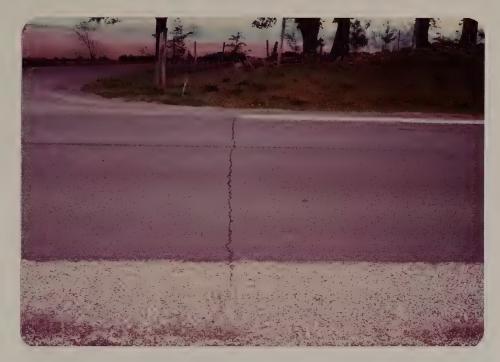
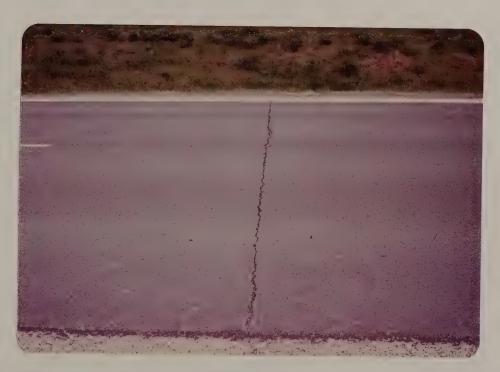
РНОТО 8

A short while after placement of the 1½ inch asphalt surface course, the shrinkage cracks in the soil cement course reflected through to the surface throughout the project. Within the test section, these cracks appeared as a relatively straight line on 20± foot centers (See Photos 8 & 9). In all areas outside the test section, however, the normal erratic cracking occurred on from 18 to 41 foot centers (See Photos 10 & 11). Further periodic inspections have indicated no change.

By all observation to date, the test method employed on this project to control the inevitable shrinkage cracks has accomplished the desired result; i.e. a relatively straight crack at a predetermined interval.

RESULTANT SHRINKAGE CRACKS THROUGH
ASPHALT WEARING COURSE IN TEST SECTION
NOTE-RELATIVE STRAIGHTNESS

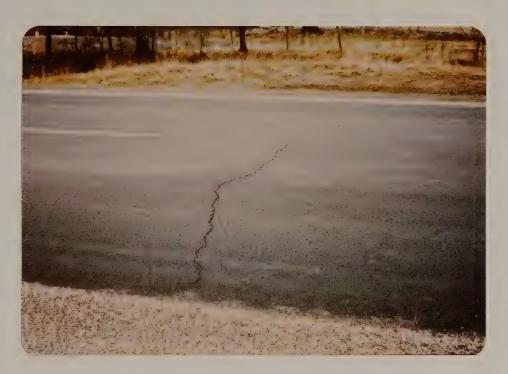
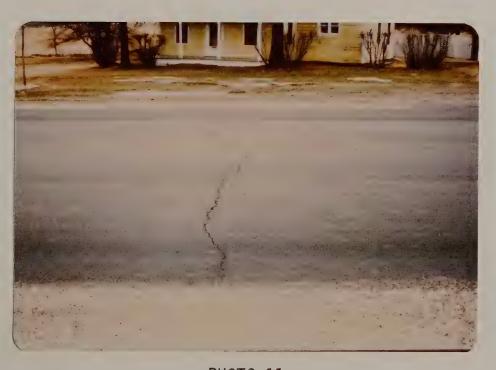
РНОТО 10

NORMAL SHRINKAGE CRACKING OUTSIDE

OF TEST SECTION

NOTE-ERRATIC PATERN
